Manhole Inspection Summary

Manhole # S37U__004MH

Location Address: **132 E randall st**

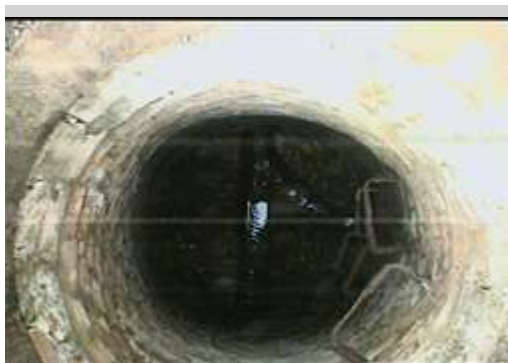
Defect 5

Condition: ☐ Sound ☐ Cracked ☐ Root Intrusion ☒ **Loose Brick** ☐ Deteriorated

corbel cond loose bricks

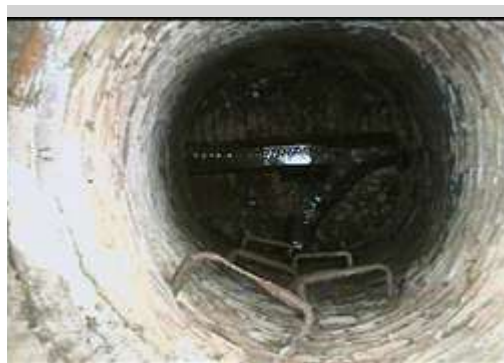
Defect 4

Count: **5** Missing: **0** ☒ **Corroded**

Step corrosion

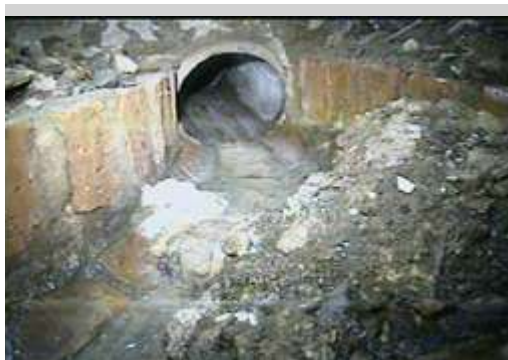
Defect 3

Condition: ☐ Sound ☐ Cracked ☐ Root Intrusion ☐ Deteriorated ☐ Leaks ☒ **Debris**

chanel deris

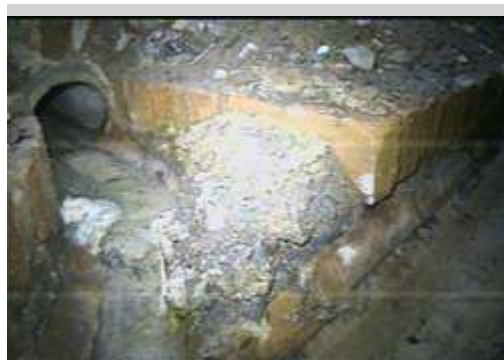
Defect 2

Condition: ☐ Sound ☐ Cracked ☐ Root Intrusion ☒ **Deteriorated** ☐ Leaks ☒ **Debris**

Missing bricks for bench

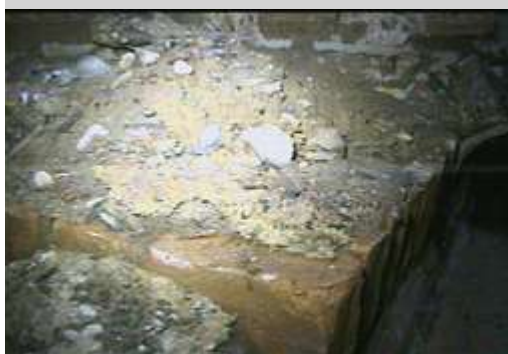
Defect 1

Bench debris

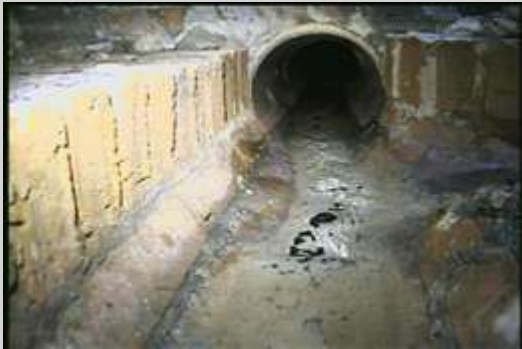
12 O'Clock Outflow

Deposits: ☐ None ☐ Mud ☒ **Sludge** ☐ Debris ☐ Grease

Silt Depth: 1 (in.) Deposits Extent: **Light**
